V-Stack Tank Spacer Improvement

By: Mike Irion VRCC 26778 3/11/11

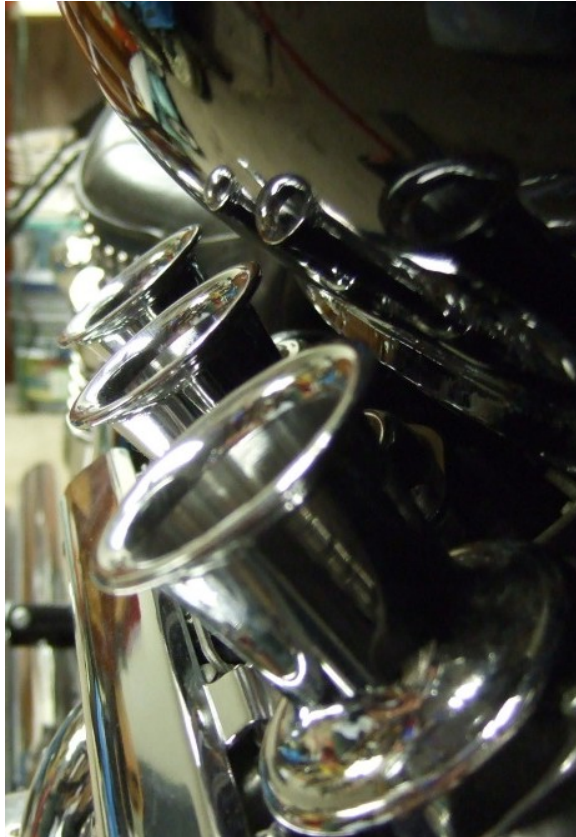
Picture shows the minimal clearance with a ½ inch spacer installed.

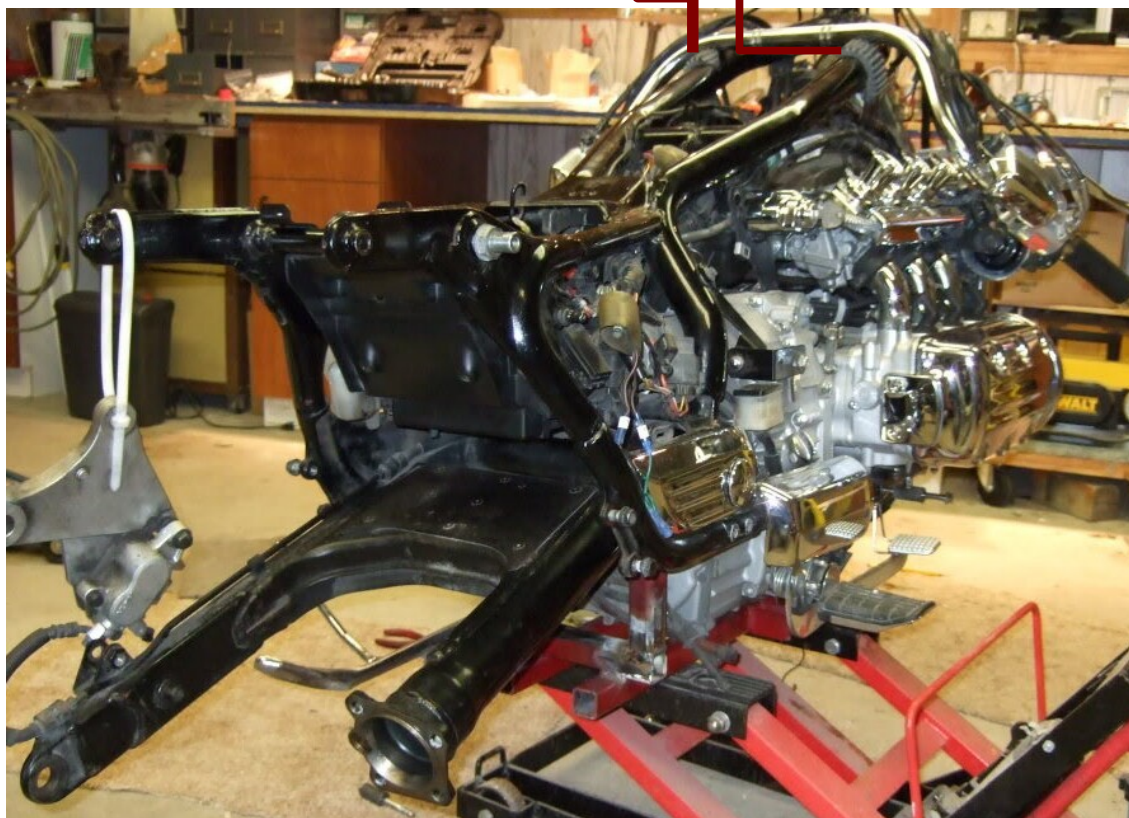
- Front (where the spacer is) that is bolted with 6mm x 40mm long screw (original is 25mm long)
- Rear that is bolted with 8mm x 35mm long screw
- Left and right rubber rest/support details on frame members

When the front of the tank is raised the recommended $\frac{1}{2}$ inch, contact with the two frame mounted rubber details is lost. This puts the full load of the tank (Approximately 60 pounds for a full IS tank) on just the front and rear points which will stress the tabs that are welded on the tank more than was intended. It also allows the tank to rock left and right on the front and rear rubber mounts because the sides are no longer supported. This rocking motion actually allowed the stacks to contact my tank and left a small dent in it. When I had my tins repainted last winter and the dent fixed, I did not want this to happen again so I implemented the following solution.
